## Chemically Speaking LLC

Jan 30, 2013

### Taiwan BF3 ERCV Incident

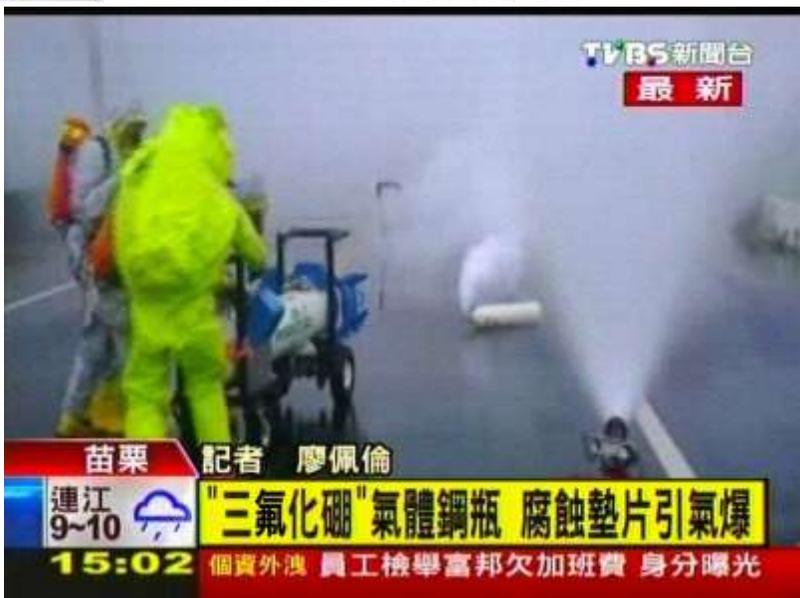
This cylinder was filled in the US to 500 psig, a level well below the maximum fill density for BF3 of 1800 psig. The cylinder valve started to leak when it was first opened through the diaphragm leak check hole. A decision was made at the customer site to overpack it in a ERCV which was a copycat version of the 5502 ERCV. The next morning when it was to be transported to the distributor site in Kaoshiung, they noticed the ERCV was leaking. A decision was made to push it out of the facility into the road and to call the Taiwan EPA ER team to bring a 5502 ERCV to repack the cylinder. The team started to open the ERCV containing the leaking cylinder but did not fully relieve the ERCV pressure. This may have been due to the copycat ERCV not having the ASME required flange safety nut for quick opening flanges. As the clamp relieved the compression on the flange it opened enough to allow the door to violently swing open. The internal pressure can exert a significant force against the door. The 12" dia door of a 5502 will have a force of 1113 lbs if there is 10 psig of pressure in the ERCV. At 100 psig this will be 11,130 lbs! This sudden and violent movement caused the door to be ripped off of the weld attachments when it swung open. The leaking cylinder was then ejected from the ERCV due to the pressure release. This may have further damaged the cylinder valve. The only damage to the ERCV was the missing door.

This picture was the scene after the ERCV was damaged and the cylinder flew out
