Chemically Speaking LLC

May 22, 2015

Christopher A. Roth, Chair
Jacqueline Wilmot, NFPA Liaison
NFPA 96 Technical Committee
NFPA
1 Batterymarch Park
Quincy, Massachusetts
02169-7471

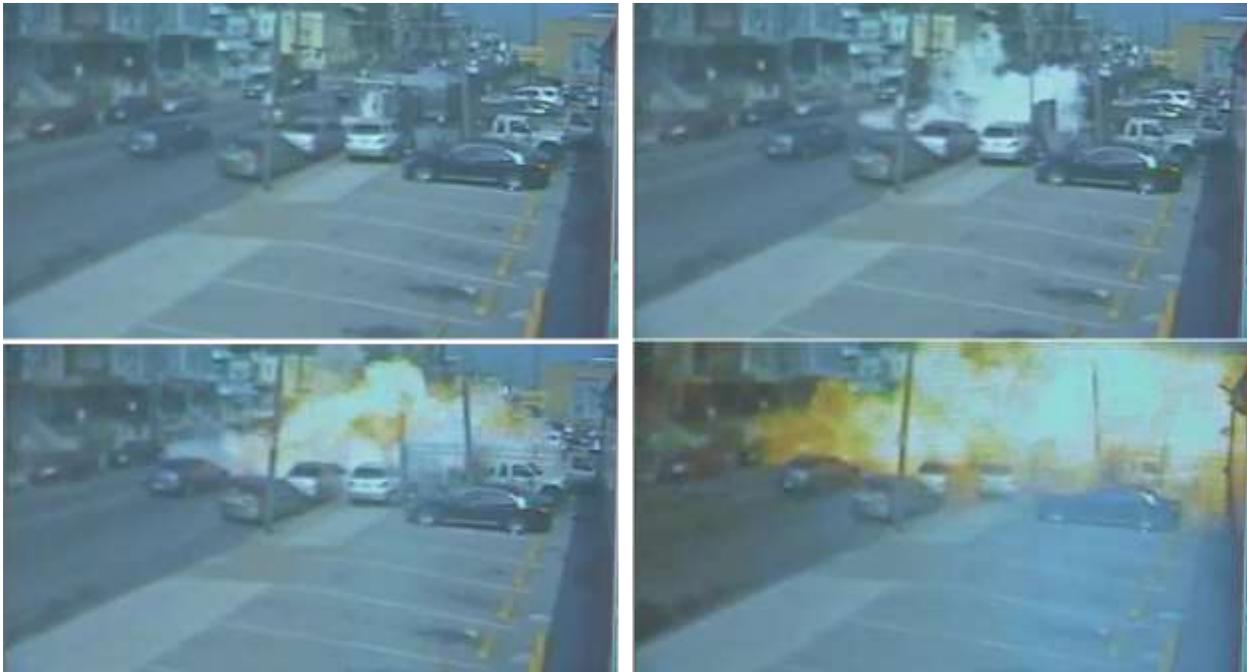
I want to clarify what happened at the Philadelphia food truck incident. I was asked to review some pictures of the cylinder and valve by one of the government agencies conducting the investigation. I was horrified to find that the Pressure Relief Device (PRD) on the cylinder was plugged. The incident was not a gas leak and ignition, it was a violent rupture of the cylinder due to liquid expansion. The incident cylinder appeared to be ripped apart in the typical overpressure failure. A frame by frame review of the video shows the following from left to right. The cylinder violently ruptures, dispersing and mixing the propane (white cloud) with air. This finds an ignition source from a passing vehicle. The flame front then propagates back to the food truck where the highest concentration is and a deflagration (overpressure) occurs.

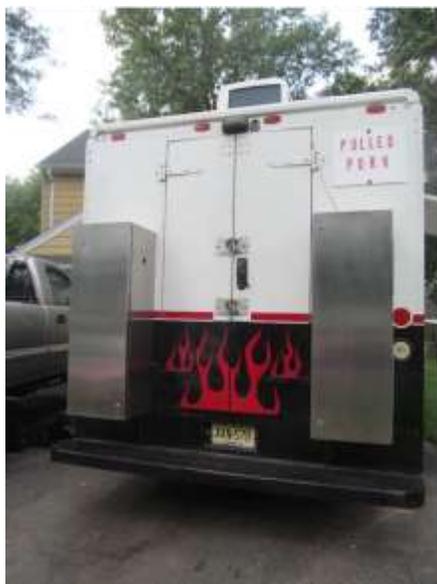
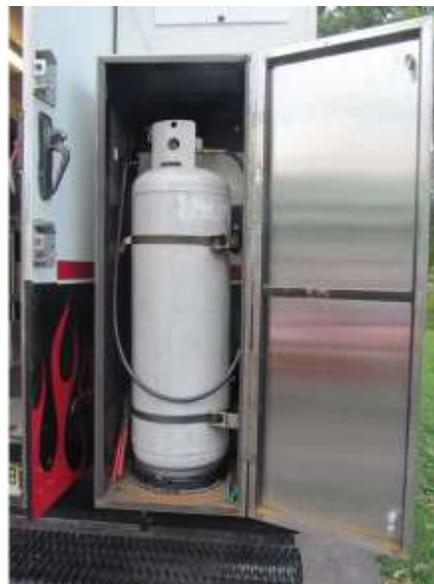
After this incident I happened to see a food truck at a local park in NJ that had a similar setup. Propane cylinders enclosed in metal cabinets in the rear of the vehicle. I asked the owner about his setup and he stated that for safety reasons he located his grill in the front of the truck. Many food trucks have them in the rear where he has measured temperatures in excess of 150°F in the cabinet. In the US the DOT limits the fill of liquefied gases such as propane based on liquid density at a temperature of 130°F. At this temperature the liquid in a properly filed cylinder will expand to fill the contents. Exceeding this temperature will cause the spring loaded relief device to relieve the pressure. Unfortunately since the relief device was plugged the pressure due to liquid expansion could not be relieved. The enormous hydraulic force of the expanding liquid caused the cylinder to rupture, propelling the propane across the street.

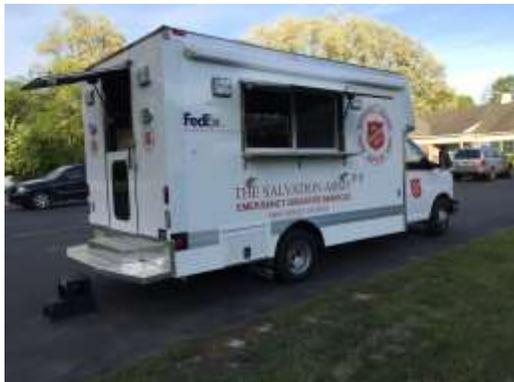
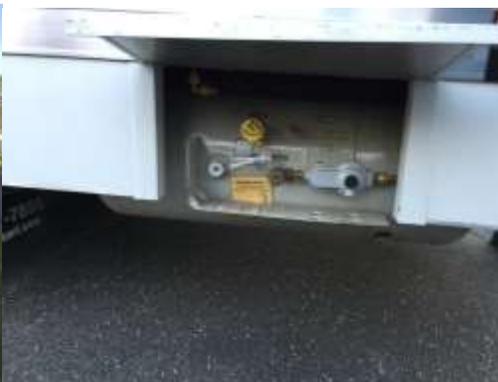
At a Community Emergency Response Team (CERT) meeting last night, the Hunterdon County Salvation Army displayed their new disaster food truck. I found their propane setup to be ideal. A fixed tank located below the floor with controls located at an exterior access door.
